## *Equipment Repair Case Study*

**Situation:** Turbine Driven Armature Repair  
A Vancouver, BC Thermal Generating Station

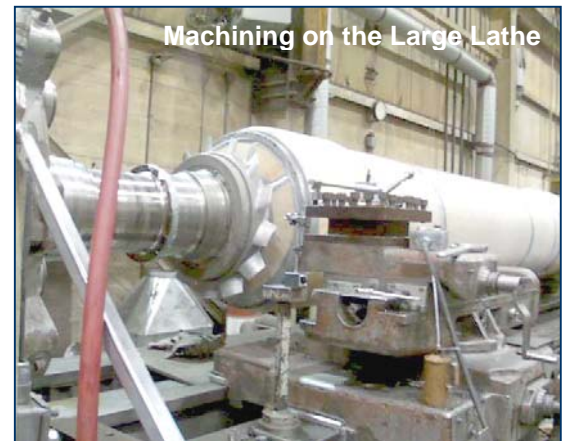
- Inadequate oil supply had caused the armature to overheat. The unit continued to run at an operating speed of 3700rpm until bearing failure occurred.
- The initial inspection indicated that the heat-affected sections of the shaft were located at the bearing seats. Further examination revealed that these areas had hardened.
- While Tristar's repair team conducted a complete inspection, including N.D.T. and run out checks, a team of engineers were flown in from the manufacturer's head office.
