Equipment Repair Case Study

Situation: 62,000lb Sump Pump Failure – High vibration levels detected
Waste Treatment Facility

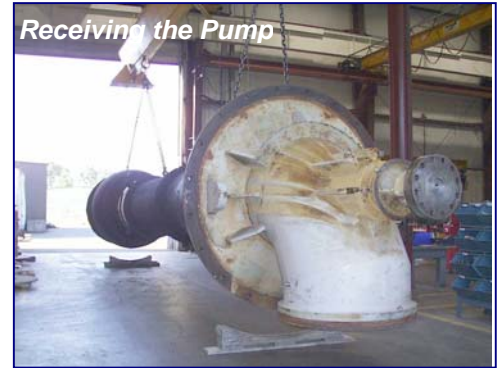
Challenge: Evaluate & repair the pump at Tristar's Delta facility.
The 62,000lb pump assembly was sent to Tristar to evaluate the cause of the high vibration levels. The unit was disassembled to assess the reason for the failure and level of repair required to return the unit to operation as quickly as possible. GVRD had been monitoring the vibration levels over a prolonged period and when the levels exceeded the manufactured tolerances, the pump was pulled from service.

- Disassembly of the pump revealed that the shaft sections were joined by means of threaded couplings, which were showing extensive corrosion.
- N.D.T. of the shafts indicated that they were not repairable.

- Working with the end user's engineering personnel, Tristar undertook the task of re-designing the couplings, while at the same time ensuring the tight tolerance of .001 over all of the fits of the shaft couplings down the full length of the 42 ft long shaft assembly.
- The full scope of repair consisted of manufacturing all new shafts, the newly designed couplings, and repairing the pump housing stages and impeller.
- Throughout the re-assembly process Tristar performed balance checks, utilizing the Schenck hard bearing balancing machine.
