Equipment Repair & Fabrication Case Study

Situation: Aging Carbon Steel Flash Tanks – Heavy corrosion causing tank failure.
Pulp Mill Facility

Challenge: Evaluate, engineer & fabricate the tanks at Tristar's Delta facility.

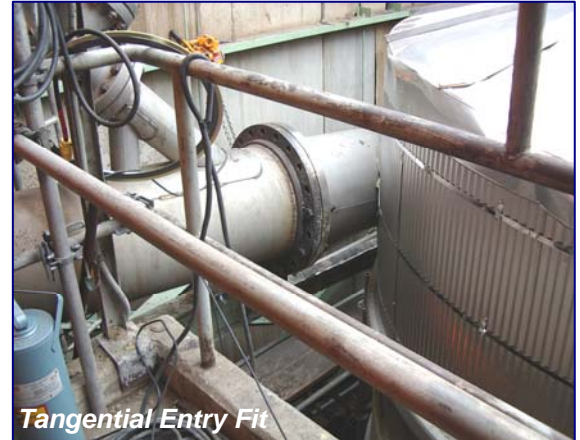
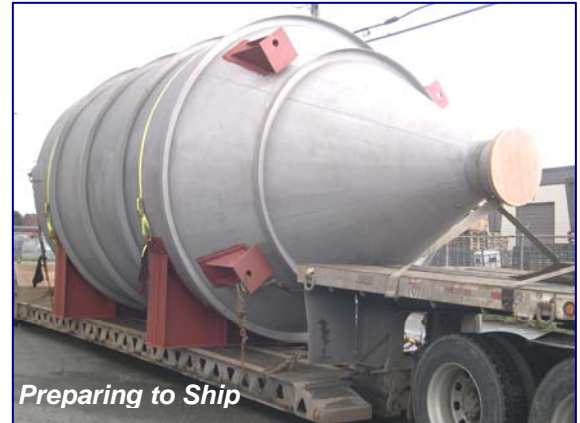
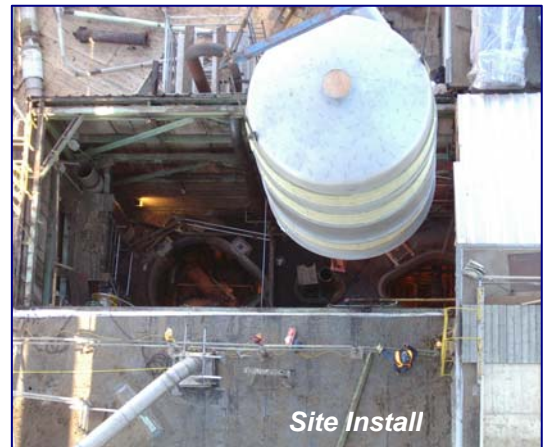
- Further evaluation indicated that the tanks were no longer straight, from the top to the bottom flange, and that the tangential entries were no longer in their original positions.
- Additionally, due to newer processes, the tanks were required to be designed for full vacuum capability.

- To solve the corrosion issues, 2205 Duplex Stainless Steel was selected as the fabrication material. This allowed for a full vacuum design, while reducing the original shell thickness.
- A 3D survey was completed, targeting all of the flange locations and bolt heads, and to identify the exact coordinates of the bolt circles. Transferring the results to AutoCad allowed a 3D model of the in-service tanks to be created along with manufacturing drawings.
- Both of the flash tanks were manufactured to the new drawings, corresponding to the mill's existing piping.

Using field data, as opposed to the original engineering, provided the opportunity to fabricate the custom tanks to suit the mill's needs. This minimized installation time and reduced overall capital costs, by re-using the existing piping. Selecting the 2205 Duplex S.S. as the construction material, allowed for thinner sections through the use of a stronger material and eliminated the risk of corrosion.

The tanks were shipped to the Pulp Mill facility two days ahead of schedule, where they were installed and are now in service at full operational capacity. Improved planning and manufacturing techniques reduced the install schedule, moving the project off of the mill's critical path for their shutdown schedule and allowed for an earlier startup.
