Equipment Repair Case Study

Situation: **Catastrophic Piston Failure, 48,000lb Diesel Pile Driver**
Vancouver Convention Centre construction site.

Challenge: **Evaluate & repair the failure, quickly 24/7 at Tristar's Delta facility**

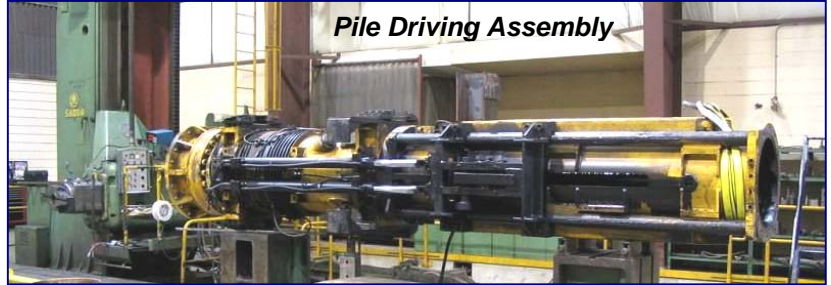
The 48,000lb assembly was sent to Tristar to evaluate the cause of failure. The piston & fuel pump assembly were disassembled to assess the reason for the failure and level of repair required to return the unit to operation to continue the pile driving schedule. Based on the tight construction schedule, the work was carried out on a 24 hour 7 day week round the clock basis

- Removing the piston revealed that the 24" diameter piston was broken into two pieces, and the fracture had occurred in the piston ring location of the unit.
- The remaining piston ring grooves indicated stress flaws.
- Two spare pistons were shipped to Tristar's facility for inspection and use in the repair of the Pile Driver assembly. Upon inspection of the spare pistons, it was noted that the same groove configuration existed that propagated to cause the failure of the original piston.

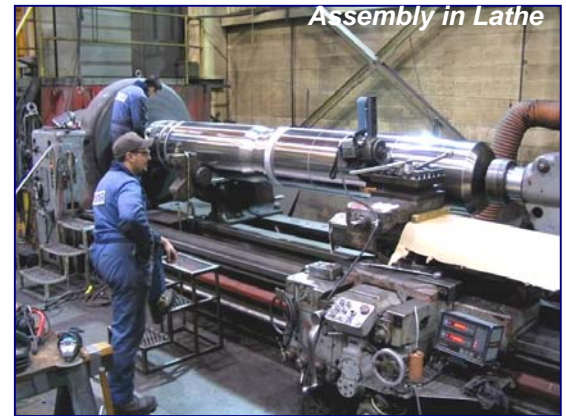
- The 24" diameter x 151" long piston weighing 20,000lb, was set up in the lathe and all modifications were completed on the ring grooves on the spare pistons. The broken piston section was machined down for use in a smaller model pile driver, utilizing the broken piston component.
- While repairs were carried out on the pistons, modifications were completed on the pile driver body to ensure a uniform mounting capability for the diesel fuel pumps.
- Additional modifications, designed to alleviate load stresses, were machined into the piston.
- Evaluation, **re-design** & repair took 7 days.

Benefits: The piston ring groove configuration was re-designed to remove the threat of stress cracking and eliminating future piston ring failure.
